47 MLB

**Watertight Door
Maintenance
&
Adjustment**

This guide is designed to aid in the troubleshooting and adjustment of WTD's onboard the 47' MLB. This guide is not a replacement for good engineering practices, preventive maintenance manuals and manufactures technical manuals.

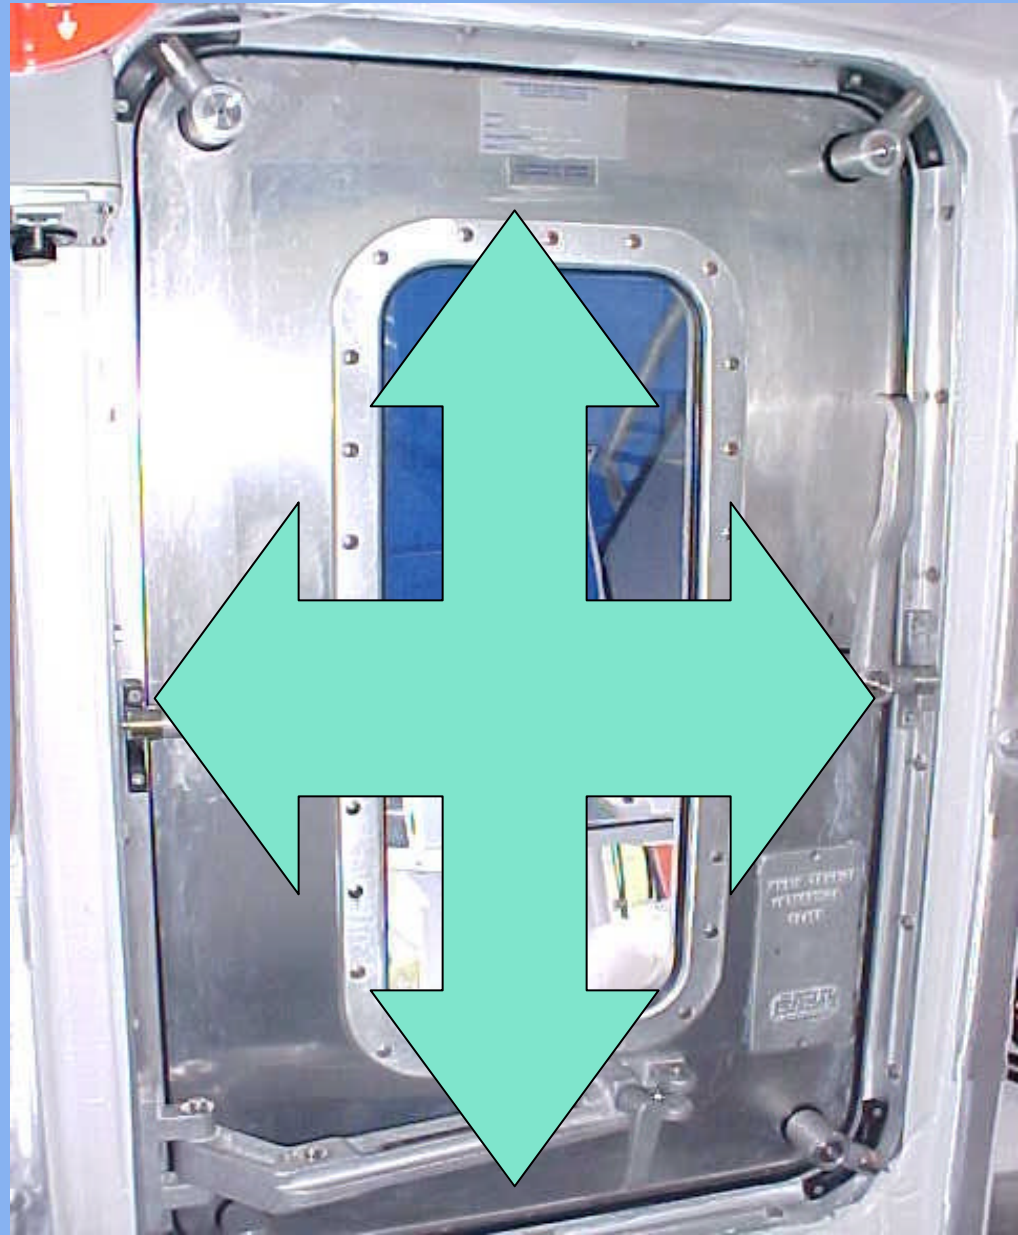
Stiff and Difficult to Operate, but has a Watertight Seal

- 1.) Check for smooth and easy operation of WTD, if stiff and difficult, screws on the dogs are over-tightened; “they should be turned down just until the assembly makes light contact against the washer shims”.
- 2.) Check outside drive handle for tightness, over-tightened drive handle will cause stiff and difficult operation.
Check for seal.

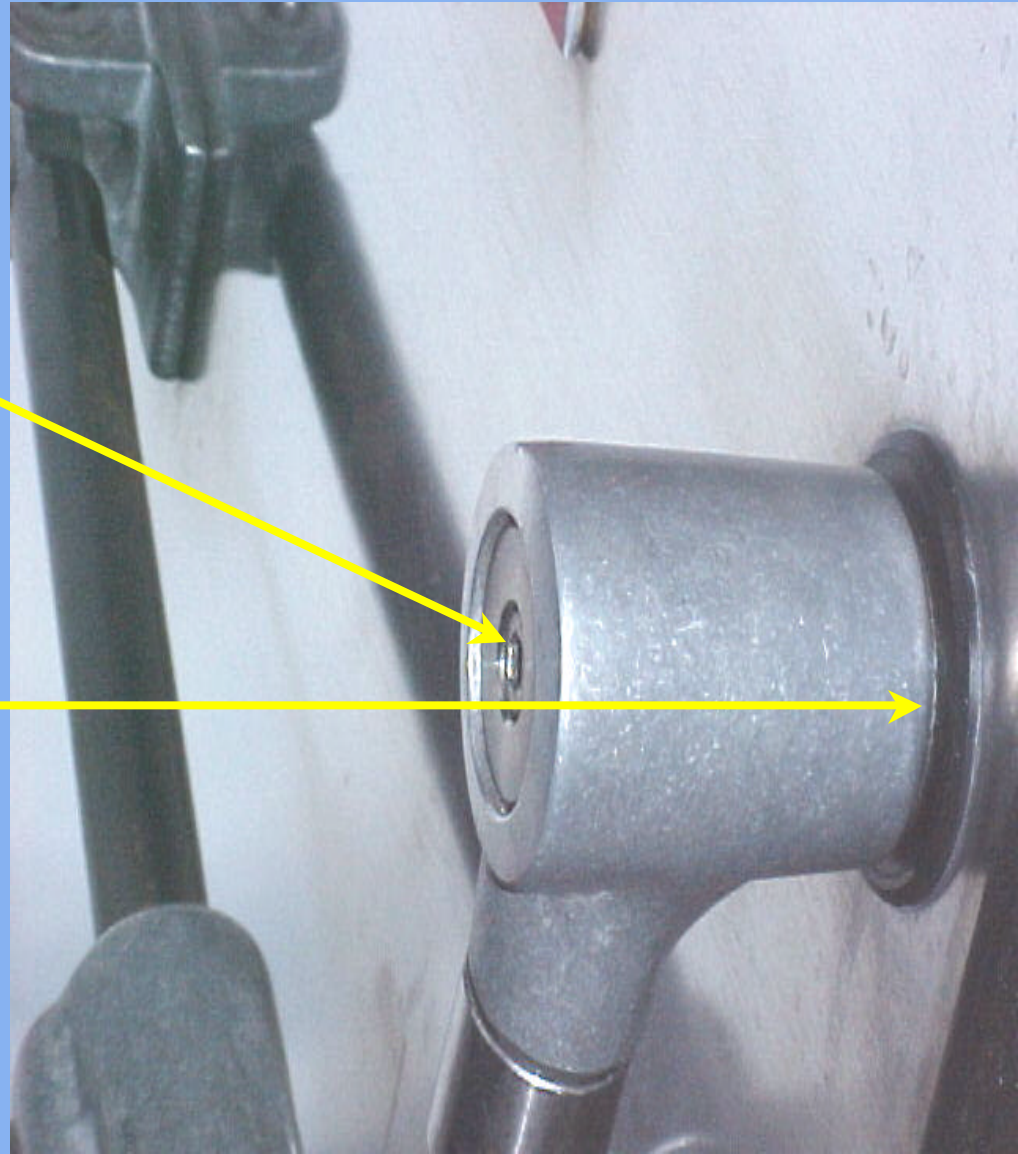
Stiff and Difficult to Operate, but has a Watertight Seal (Cont.)

- 1.) If stiff and difficult, then dogs are out of adjustment and binding. With door closed and dogged, loosen all dogs so they do not make contact with the striker plate, starting from the top handle side of the door, alternating between handle side and hinge side, tighten the dog so it makes light contact with shim washers, if it makes contact with shim washers and not the striker plate, remove shim washer(s). **Check for seal.**

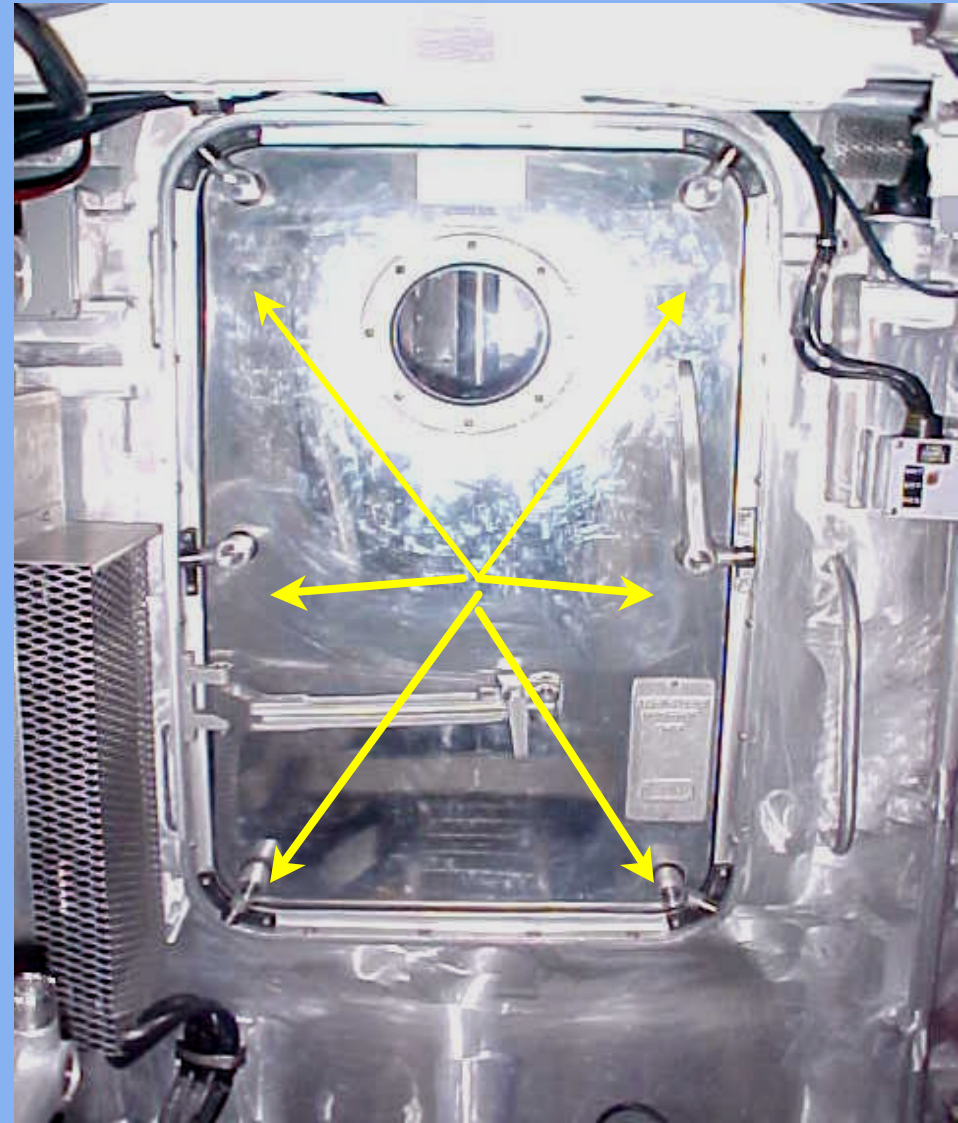
Door Gasket Makes Contact With Doorstop on Hinge Side Before Door is Closed

- 1.) Readjust doorstop in or out as needed. When performing this step, loosen all the bolts and slide the doorstop in, close the door and move the stop up to the gasket on the door.
- 2.) Ensure it's even around the whole stop and tightened the bolts alternating between sides. Adjust dogs as per #1.

Note: Adjustment of the door stop surface can cause sealant to tear and will require resealing. “Sikaflex or other quality marine adhesive sealant” is recommended.

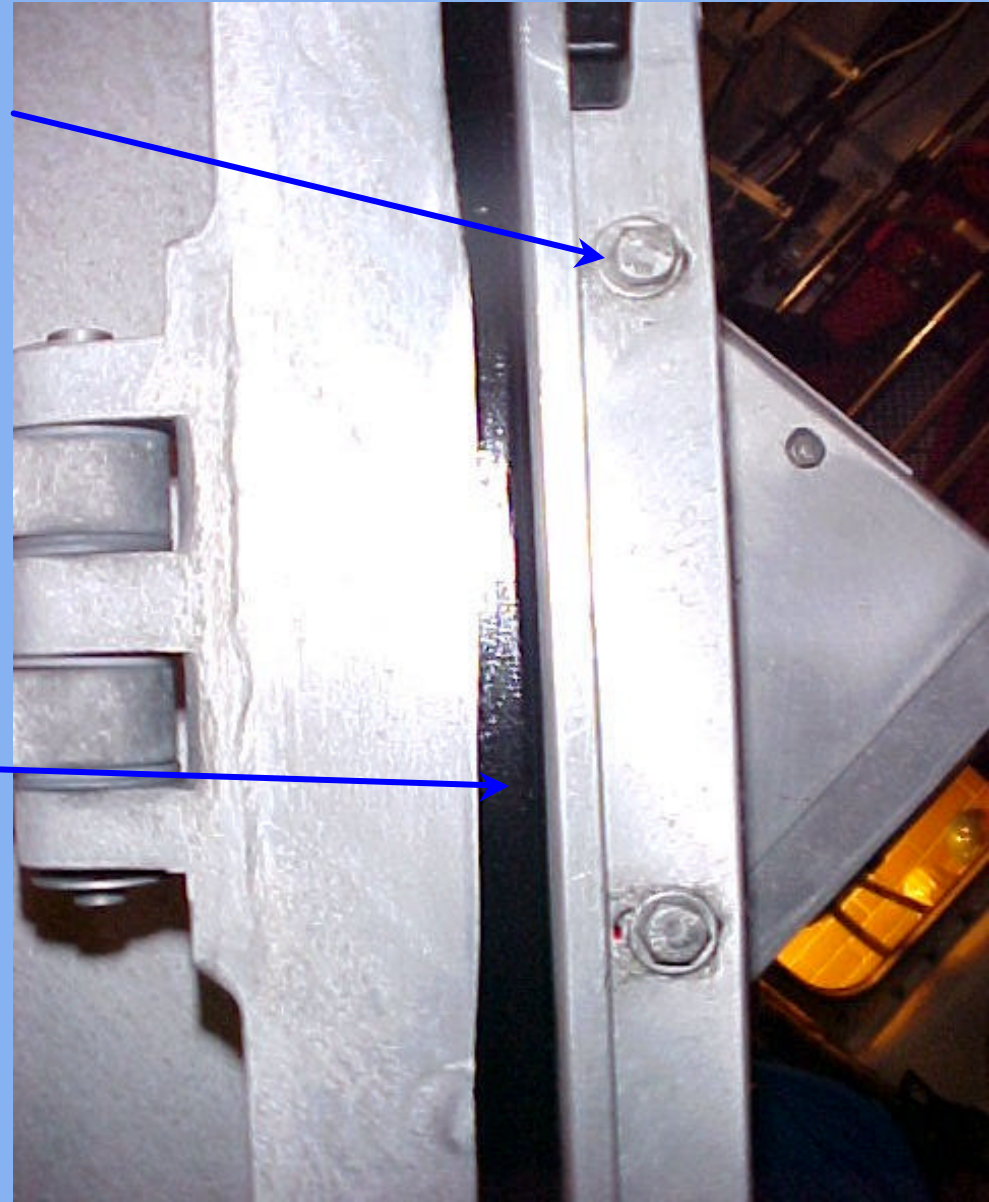
EWRS Window Fails to Seal Latch Side

- 1.) Check condition of gasket.
- 2.) Check adjustment of wedges on latch.
- 3.) To adjust wedges, loosen nylock nut(s) and slide wedge down. Retighten nylock nut(s).

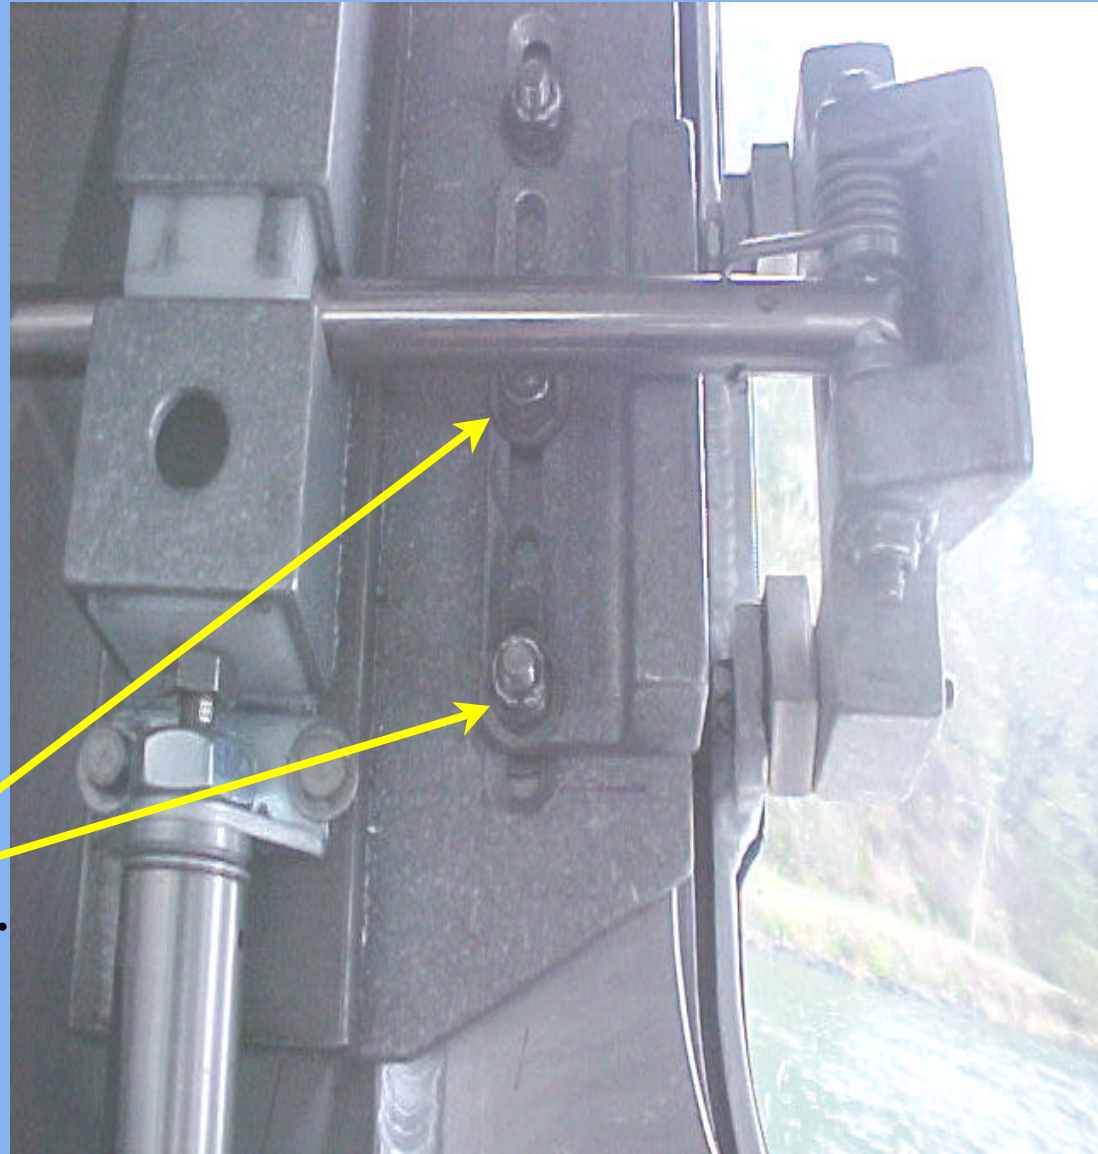
EWRS WINDOW Fails to Seal Hinge Side

- 1.) Adjust hinges in or out as need using setscrew.
- 2.) If window is binding at the hinge, adjustment can be made by rotating the hinge bolt in or out, removal of the window from the hinge is necessary.

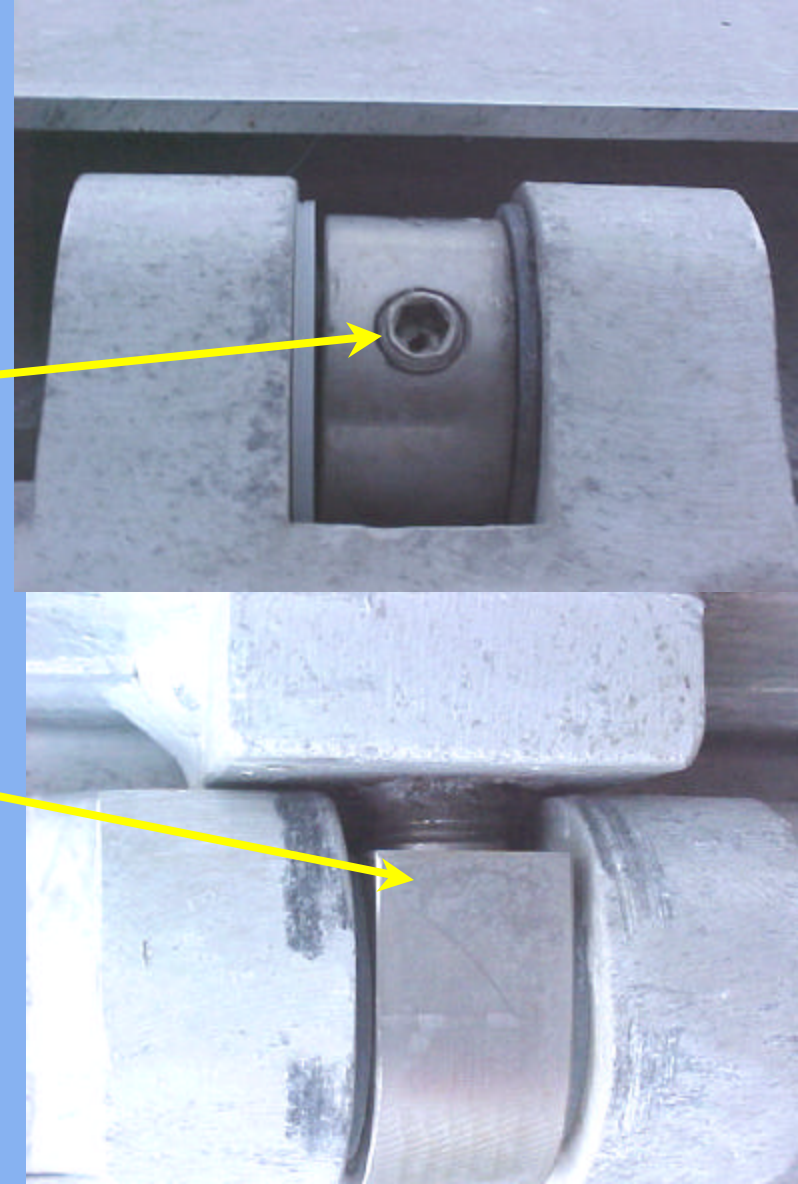
Opening Window Fails to Seal Hinge Side

- 1.) Check condition of gasket.
- 2.) Adjust hinges in or out using setscrew.
- 3.) If window is binding at the hinge, adjustment can be made by rotating the hinge bolt in or out, removal of the window from the hinge is necessary.

Check for seal.
